ASBESTOS REGISTER and MANAGEMENT PLAN

71 Kensington Road
NORWOOD

April 2016

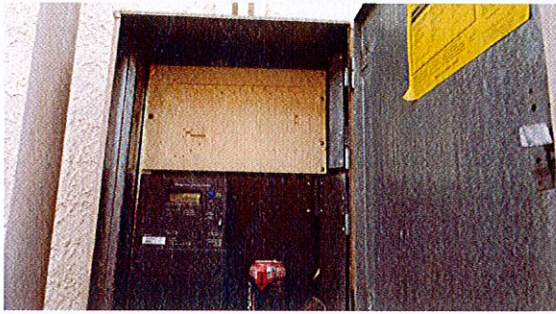
Photo 1: External meter board is asbestos free.

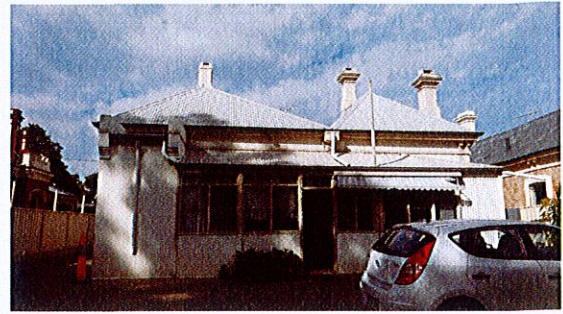
Photo 2: External wall claddings are asbestos free.

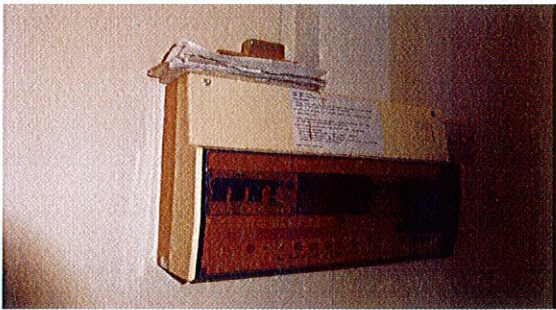
Photo 3: Internal fuse board is asbestos free.

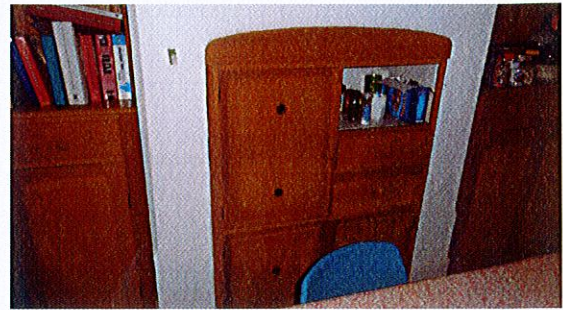
The gas space heater, and the fire places, including in the kitchen were not inspected internally.

Photo 4: Kitchen stove alcove could not be inspected.

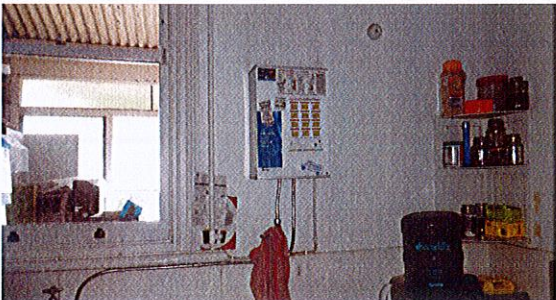
Photo 5: Kitchen hot water unit is asbestos free.

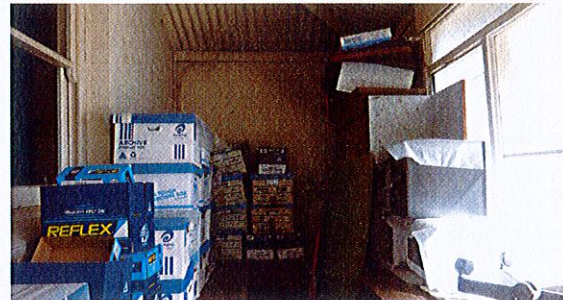
Photo 6: Rear porch wall cladding is asbestos free.

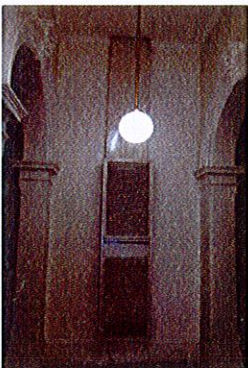
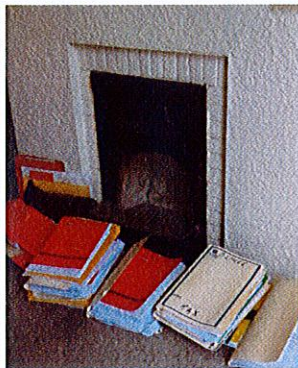
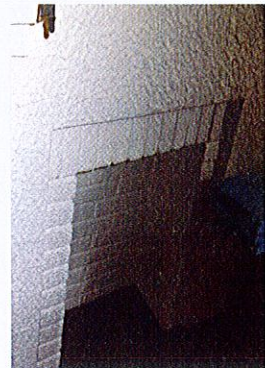
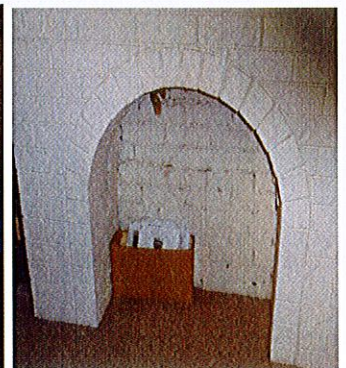
Photos 7: Space heater and the various fire places were not examined internally.
